# Case study: Managing water for the farm and environment with Jeppesen Farming Company

Tony and Mandy Jeppesen, along with sons Ben and Sam, own and manage a cane farm in the Whitsunday region of Queensland. Over the past decade, the Jeppesens have implemented changes across the farm to improve water management.

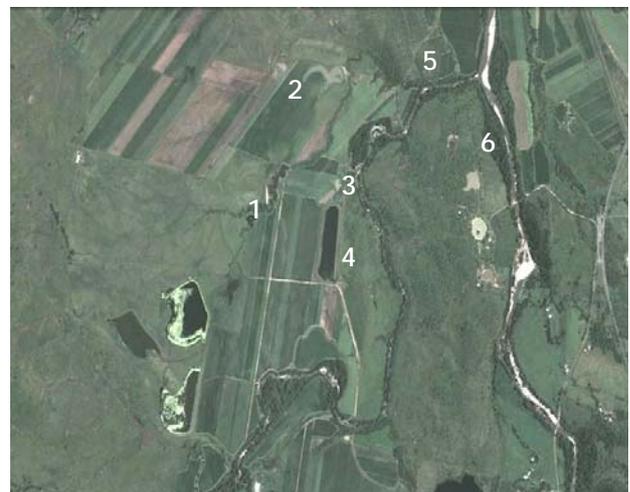
Satellite image showing current water structures and drainage on the farm and surrounding areas:

- 1—existing dam
- 2—constructed wetland
- 3—detention basin - *smaller structure that traps run-off and sediment off a set area of the farm*
- 4—ring tank - *larger structure that needs to have water transferred into it as it has no catchment*
- 5—Horse Creek
- 6—O’Connell River

A number of structures, described in more detail in the following sections, are now in place on the cane farm to manage water as it moves across their property.

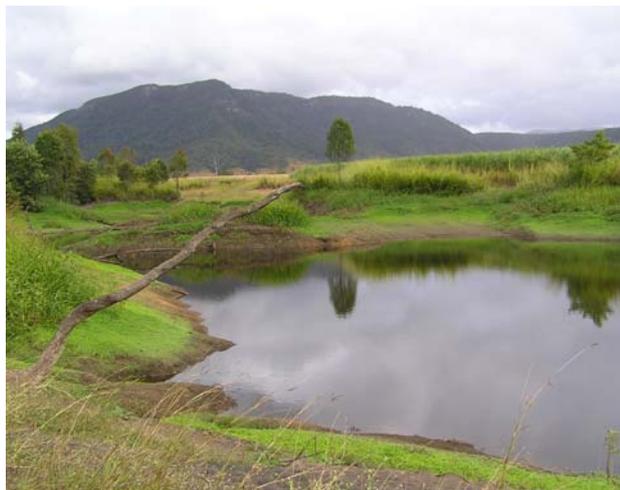
The existing dam provides water for irrigation, biodiversity and water quality outcomes. Photo: QDAFF

One of the first actions the Jeppesens completed was to link an existing dam (1) with new irrigation infrastructure to allow some of the trapped water to be transferred and used around the farm. This dam provides good habitat. Not all of the water from the dam is used for irrigation. This ensures there is some available for habitat and wildlife refuges during dry periods.

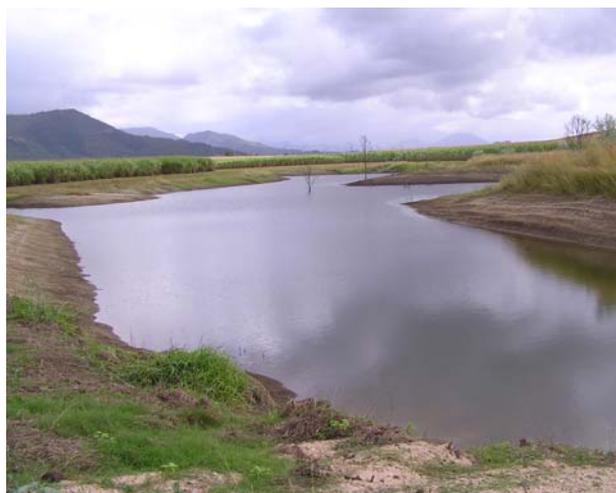
Wetland constructed in 2007. Photo: QDAFF

In 2007, the Jeppesens received funding from the Queensland Government to construct a wetland. One of the aims of the wetland was to provide water quality outcomes through increased detention time by allowing the settling of sediments and removal of nutrients and pesticides. **'We could also reuse the water and transfer it around the farm to retain any pollutants within the system,'** Tony said. This is more of an 'as required' action.

The wetland provides a range of biodiversity and water quality treatment features:

- **Island**—this was planted with native trees to provide extra shelter for wildlife.
- **Habitat variety**—a number of shallow and deep water sections provide a variety of habitat zones.
- **Deep section**—an important refuge during the dry season for fish and other aquatic animals that help to control mosquito breeding.
- **Shallow zones**—favoured by many of the native birds that use the wetland. These areas were also designed to promote the growth of macrophytes.

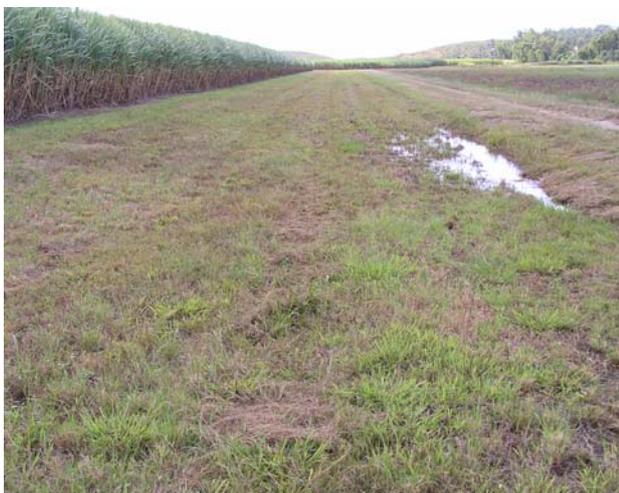
The priority was to fix up drainage paths to improve flow throughout the farm. Photo: QDAFF

'Between 2006 and 2010, many of the farm drains were re-surveyed and levelled to improve water flowing between blocks.

We have them all grassed and directed into at least one of the treatment structures on the farm'.

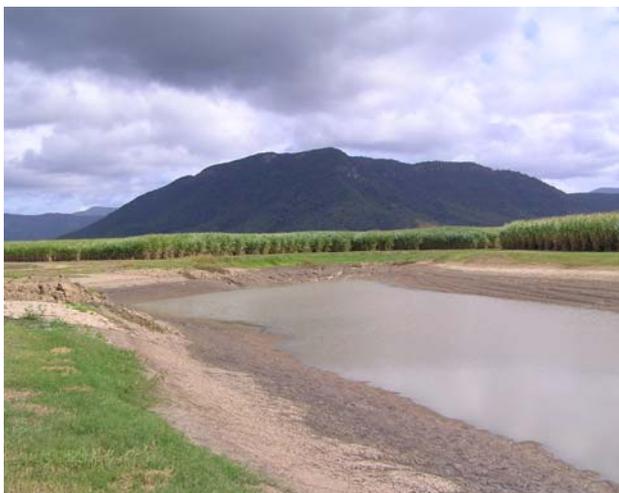
Detention basin acting as both a sediment trap and a sump for a larger ring tank. Photo: QDAFF

In 2006, the Jeppesens secured funding from the Natural Resource Management Group, Reef Catchments, to build a detention basin. This was designed to act like a sediment trap and able to capture a first flush event, 30mm of run-off, from 30ha of cane blocks—around 9ML capacity. It was located so that it could also act as a sump for a larger ring tank (refer next section) allowing captured water to be transferred to the ring tank, freeing up the detention basin to catch the next run-off event.

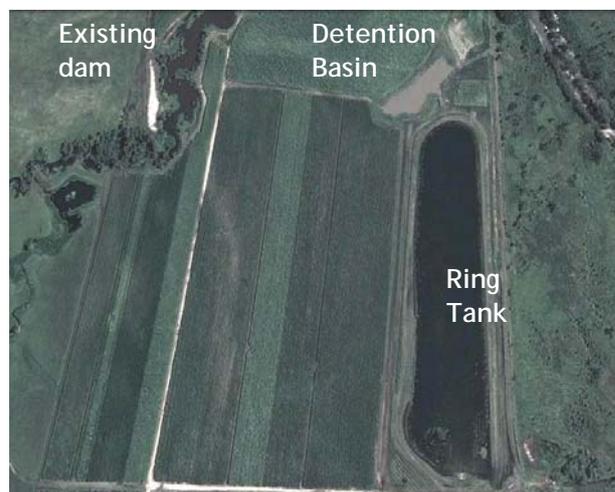
Satellite image of detention basin and ring tank. Photo: Reef Catchments

To help with the re-use of the water, in 2009 the Jeppesens sacrificed some cane land to build a large ring tank with a holding capacity of 150ML. The aim was to transfer some of the run-off that goes into the detention basin and wetlands into the larger structure so that it can be utilised after the wet season for

irrigation to improve crop production. This also means that there is less dependence on getting water from the O'Connell River during low flow periods.

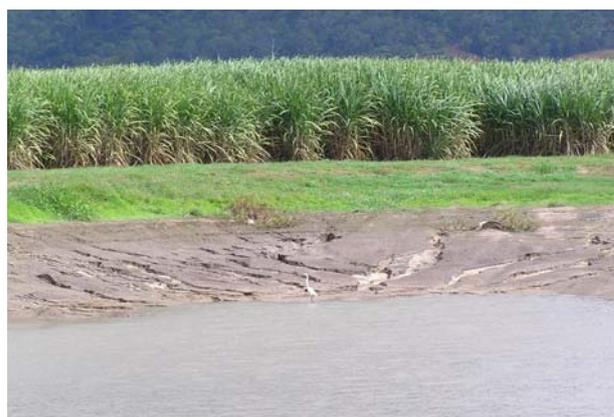
Detention basin and grassed headland showing sediment being trapped from recent flow event. Photo: QDAFF

**Water quality**—There has been a significant reduction in the amount of sediment lost from the farm as it is now trapped and able to be reused back on farm. Improved land management practices and the ability to now detain and reuse run-off within the system will also reduce the risk of nutrient or pesticide losses into the local creek and then into the Great Barrier Reef Marine Park.
