Case Study: De Moleyns Lagoon rehabilitation and monitoring project

QWP/2013/12

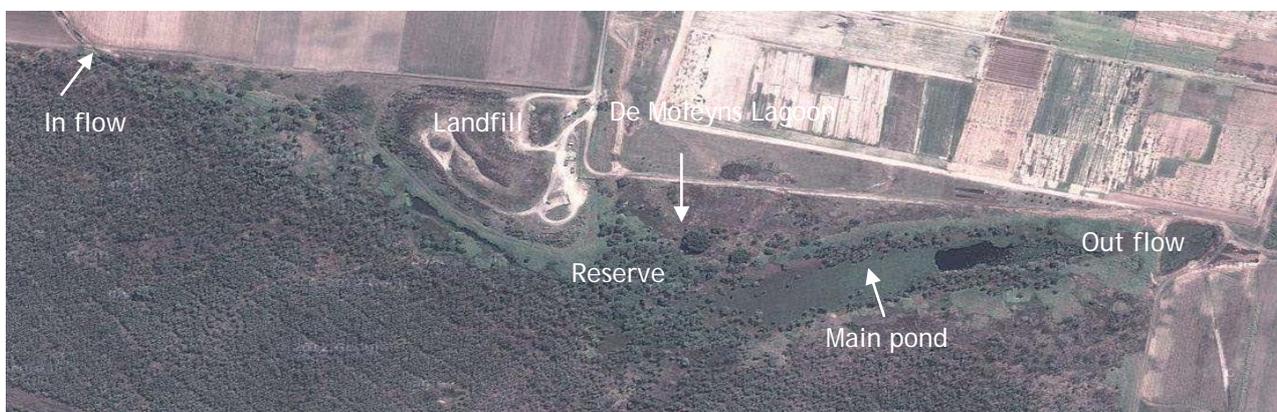
The wetland comprises three open water areas (with small ones along the channel) and is just over 1.1km in length from the inflow point to the outflow.

De Moleyns Lagoon aerial photo. Photo: Reef Catchments

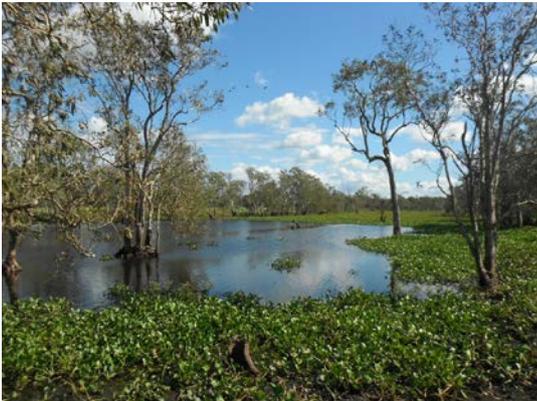
Water hyacinth covering the main pool of De Moleyns Lagoon Photo: DAFF

One of the most visual impacts on the wetland is the water weeds covering the majority of the open water section of the wetland. A range of methods are being

used to reduce the infestation, such as biological controls, mechanical removal and increased shading along the edges of the wetland from revegetation work.

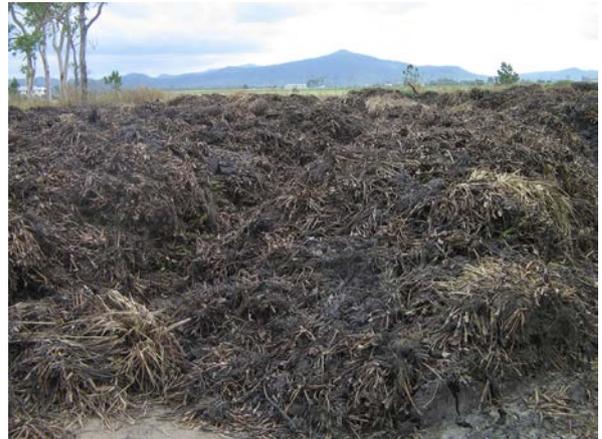
A significant quantity of water hyacinth was removed from the wetland. Photo: DAFF

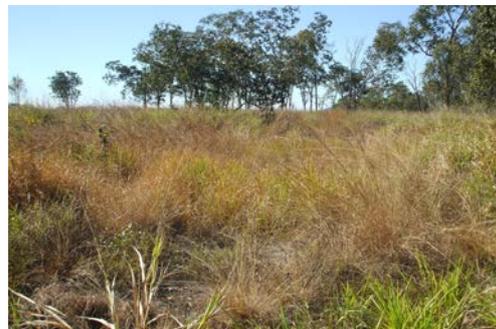
Sprayed giant rats tail grass. Photo: DAFF

As access improved, spraying has been used to control weeds such as lantana and giant rats tail grass. The Mackay Regional Council and landholders will participate in a weed maintenance program to reduce the risk of weeds recolonising the site after control.

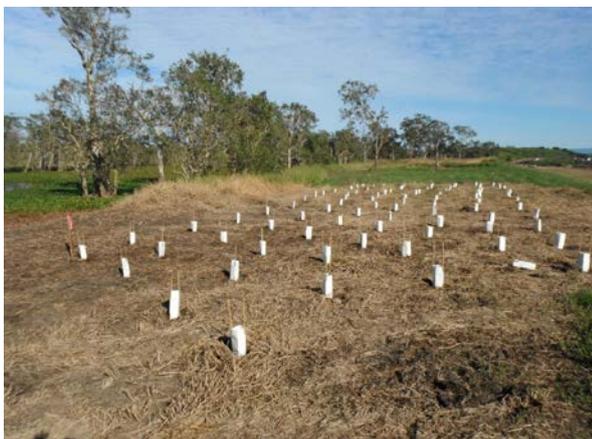
Newly planted trees. Photo: DAFF

Some of the areas slashed and sprayed have been revegetated with local native species grown from seed and sourced from the region.

As the area is a wetland, species planted must be able to tolerate 'wet feet' for extended periods during the year. Species used have included *Melaleuca viridiflora*, *Lophostemon sauveolens* and *Nauclea orientalis*.

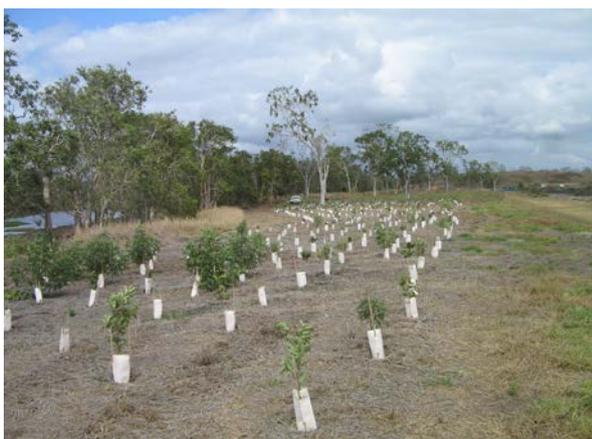
Revegetation at De Moleyns Lagoon. Photo: DAFF

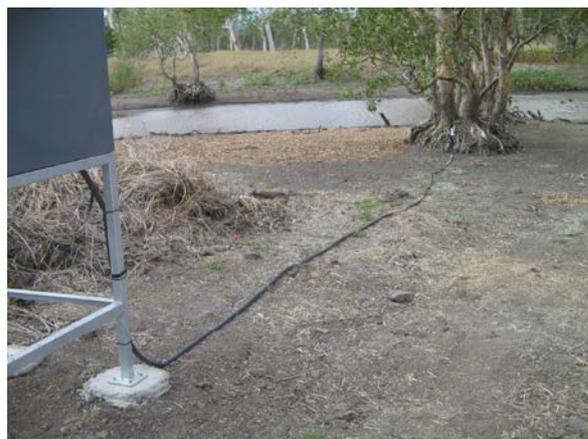
Autosampler ready to capture first event to flow through the lagoon. Photo: DAFF

The water quality monitoring program will establish the quality of water entering the wetland from the upper catchment and determine the degree to which the wetland, in its current state, provides water quality improvement benefits.

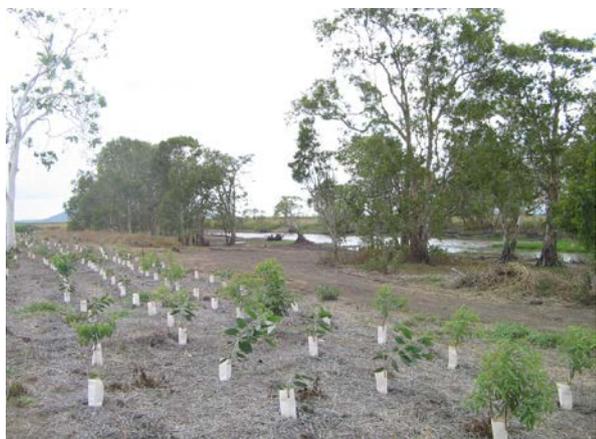
Trees showing significant growth four months after planting. Photo: DAFF

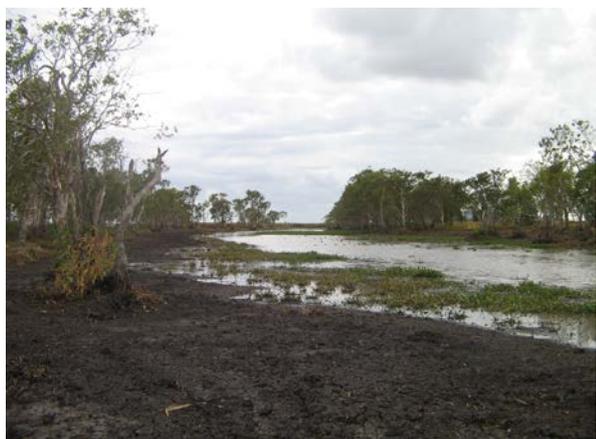
Main lagoon after water hyacinth removal. Photo: DAFF
